Overcoming Mechanical Drilling and Registration for High Layer Count RF and Digital PWBs Containing PTFE

Thomas F. McCarthy, Oliver Zhu
Taconic

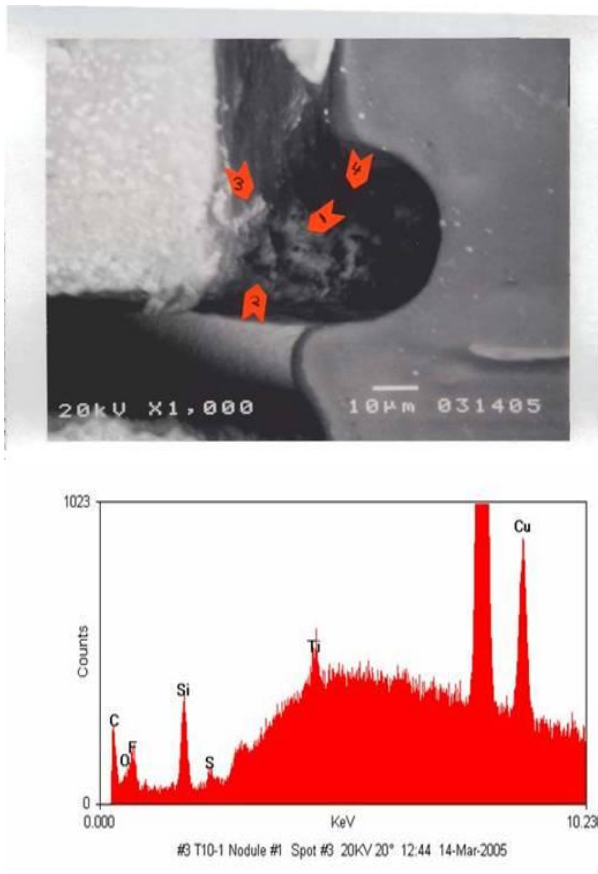
Figure 5. Scanning electron micrograph and EDX scan of an 18 layer PCB after the board has been sectioned and the copper plating removed by etching leaving the bare hole wall and potting compound in place.

still in place. Figure 5 shows the multilayer PWB after the through hole was sectioned and the plating removed. The interconnect pad can also be seen to have been removed during etching. Directly above where the interconnect pad used to be is a loose collection of bound particles. EDX shows PTFE, titanium dioxide, and silica. The fact that the loosely associated group of particles rests just above the interconnect pad strongly suggests that the dominant mechanism causing these defects is the interconnect pad scraping drill bit debris off the bit as the bit enters and exits. After thoroughly analyzing other areas showing the same defect as Figures 3 and 4, the evidence is compelling that the mechanism resulting in these hair-like voids and nodules is debris that builds up onto the drill bit and scrapes off onto the sidewall when the bit hits a copper interconnect pad. This loosely associated lint-like collection of particulate then challenges the plating process. Electroless and electrolyzed plating chemistry try to plate in and around the random collection of debris that is attached to the side wall leaving plating voids.

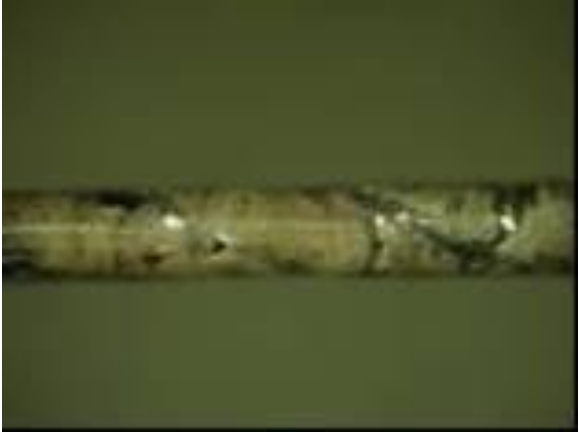
Figure 8 Twenty mil diameter straight shank drill bit completely inundated with drill bit debris

Figure 8 shows the condition of a drill bit inundated with debris. Good drilling parameters should allow no debris to accumulate in the flutes of the bit. Drill bit debris can be removed from the bit by drilling the contaminated bit into a hard material like phenolic. The objective is to abrade the drill bit debris onto the hard sacrificial entry material. One DOE began by drilling twenty 0.0028" holes into a 200 mil thick ceramic filled PTFE multilayer PWB (Figure 9a, left). The PWB was removed from the drill table and replaced by a 160 mil slab of phenolic. Drill bits full of debris were drilled 20

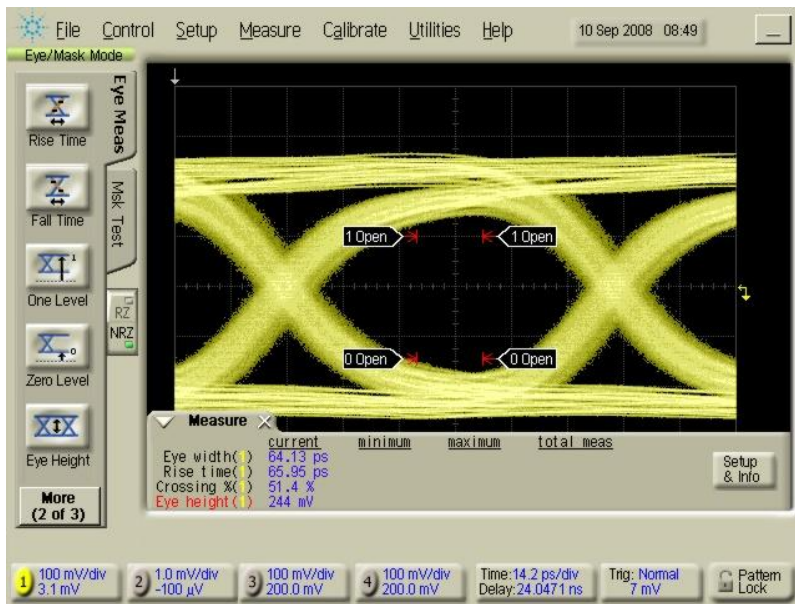
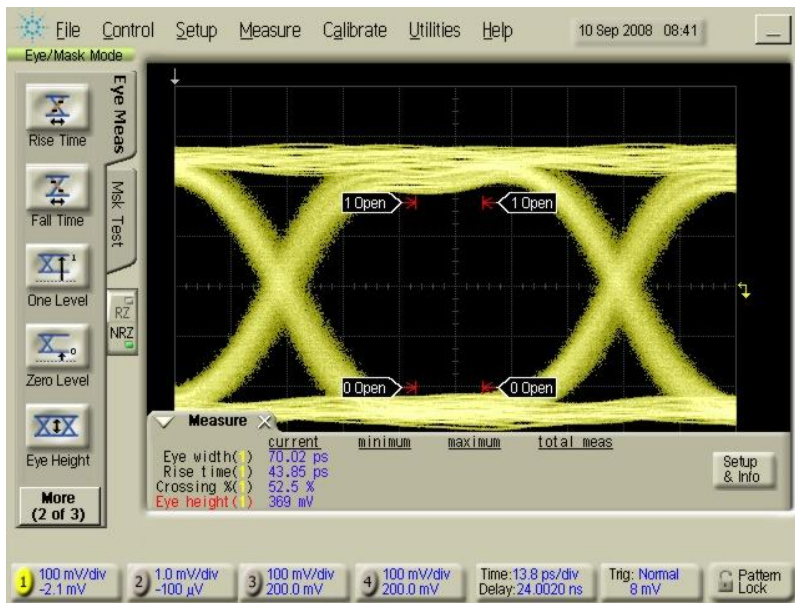
Figure 14 Digital Eye patterns at 12 gbps of a fiberglass reinforced laminate comprising rubber, a brominated flame retardant, and silica (top, known in the industry as hydrocarbon) versus the same test vehicle manufactured from a fiberglass reinforced ceramic filled Teflon® core and a non-reinforced silica dominated low temperature prepreg (bottom).

no fiberglass reinforcement. Figure 12 shows the digital eye patterns at 12 gbps of the non reinforced prepreg with the ceramic filled Teflon® core versus a reference material comprising rubber, silica, brominated flame retardant, and ≈ 33 wt% fiberglass, known in the industry as hydrocarbon. The rubber based substrate shows an eye height of 244 mV versus 369 mV for the Teflon® containing substrates. The rise time is more noteworthy. The PWB based on the non-reinforced prepreg had a rise time of 43.85 ps vs 65.95 ps for the rubber based PWB. This large difference in eye height and rise time is more pronounced at 12 gbps than was published in another investigation published elsewhere³, where the gains in the 10 gbps range weren't as obvious. Each of these eye patterns is taken with a PRBS 2^{31} pattern along a differential 4.25 inch trace at 12 GB/s. The rubber based substrate had an insertion loss of -5.5 dB while the PWB containing the non reinforced substrate had an insertion loss of -2.3dB. Identical trace lengths of 14 mil width were used.
